**REPORT ON INVESTIGATION OF FIRE AT UCNC, Y-12 PLANT,  
BUILDING 9766 ON MARCH 21, 1962**

REPORT OF THE INVESTIGATING COMMITTEE  
ON THE  
FIRE AT OAK RIDGE, TENNESSEE  
Y-12, BUILDING 9766,  
MACHINE HOOD, DUCT SYSTEM AND FILTER HOUSE  
MARCH 21, 1962

OAK RIDGE, TENNESSEE  
DATE OF SUBMISSION: APRIL 6, 1962

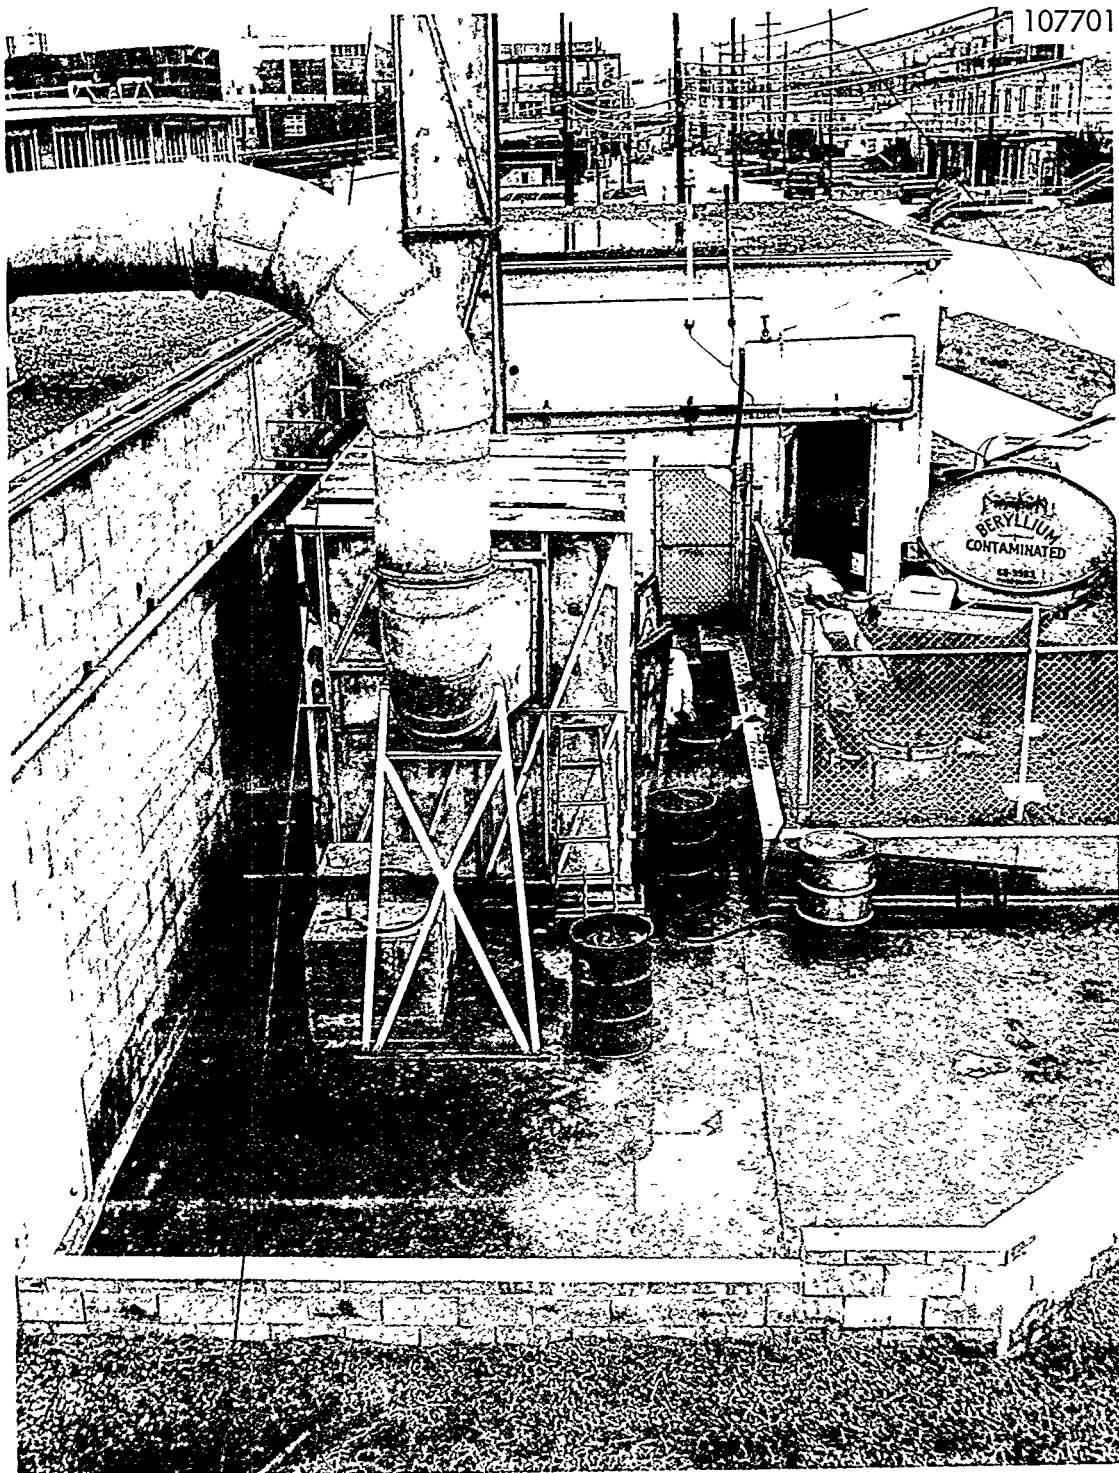
Figure E-1. OVERALL VIEW OF FILTER HOUSE.

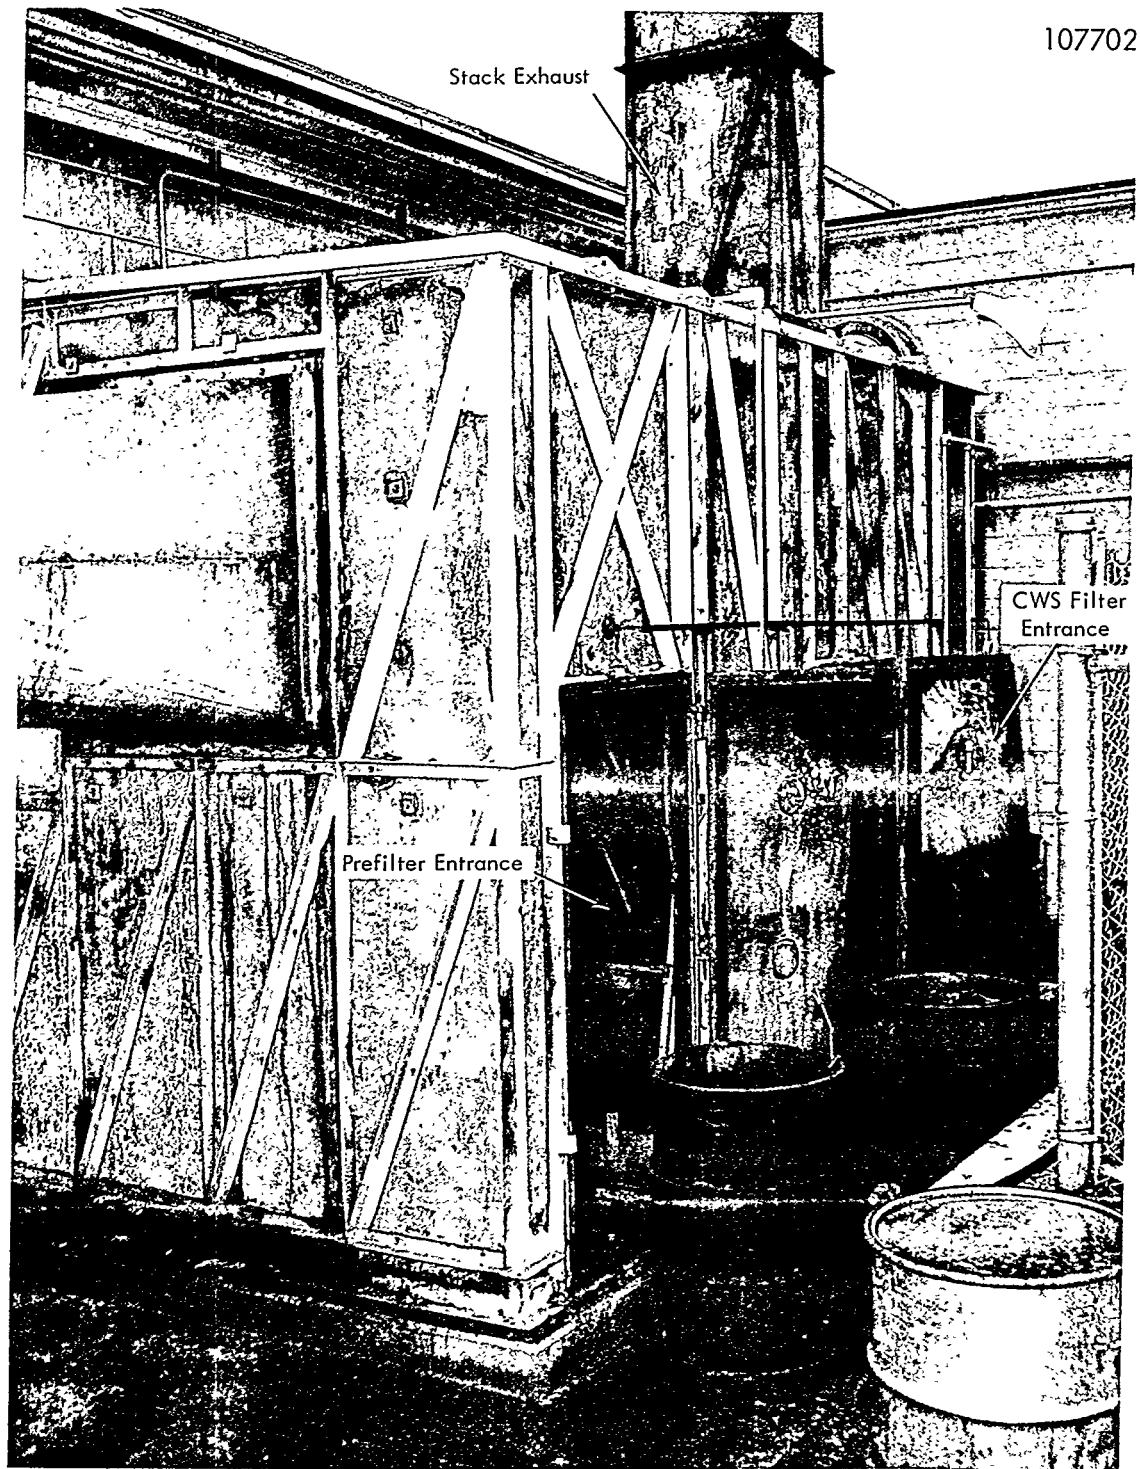
Figure E-2. CLOSEUP VIEW OF FILTER HOUSE.

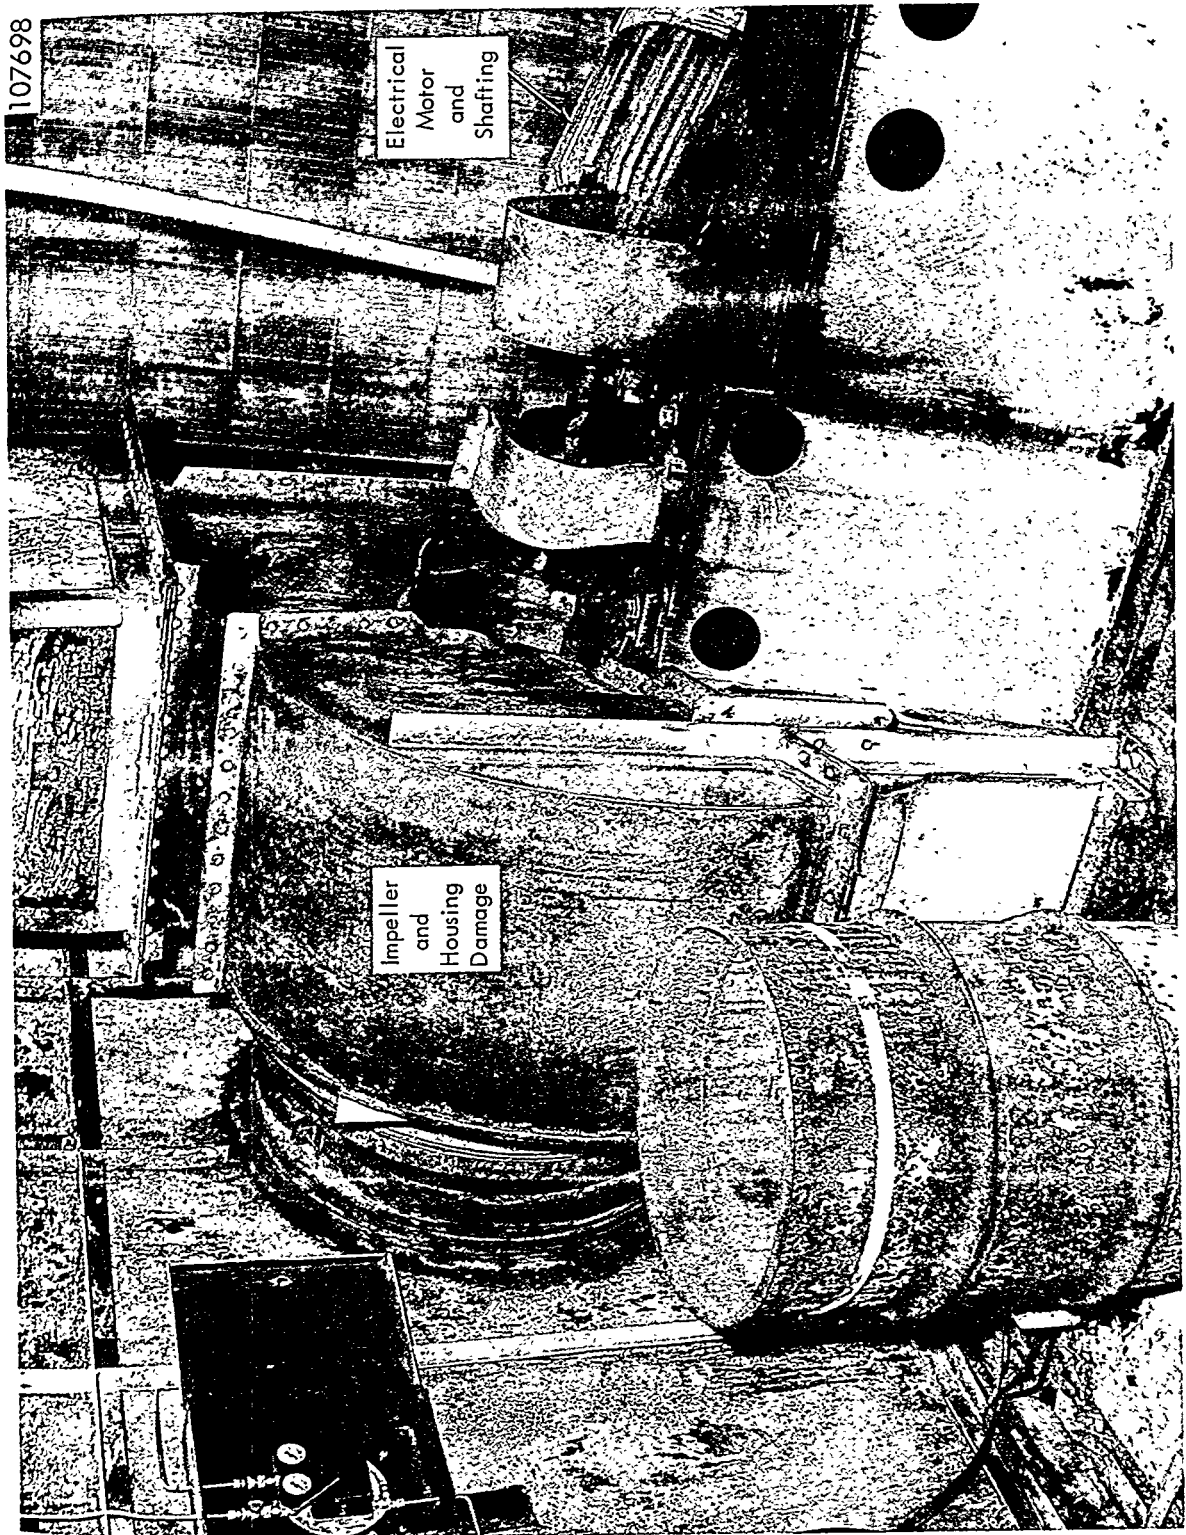
Figure E-3. FILTER HOUSE FAN.

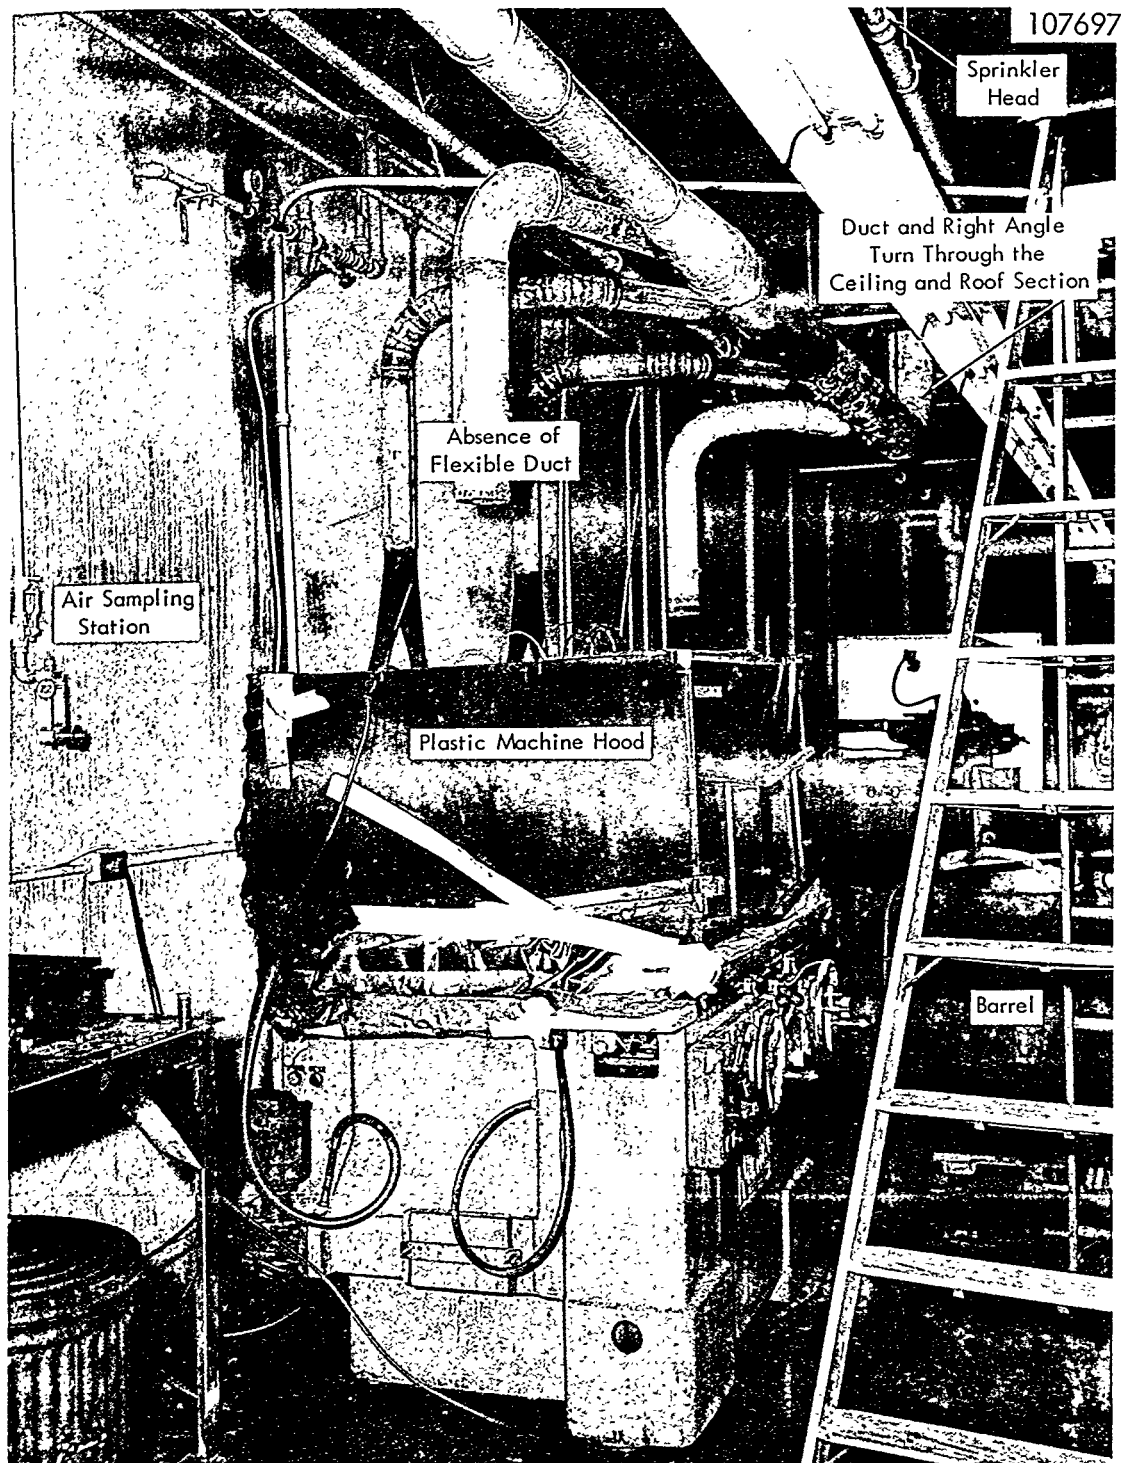
On March 21, 1962, at approximately 4:30 P.M., a machine cleaner started to remove dust and clean a grinder in the shop area in a room in the northwest section of Building 9766. This machine had been used over a period of several weeks to grind the surface of a material which produces a pyrophoric dust. The grinder was enclosed in a plexiglass hood and perchloroethylene coolant was used during the grinding operation. Appendix F, Figures F-1 and F-2, gives views of this hooded grinder. When the cleaner advanced the stainless steel nozzle of the vacuum cleaner into the enclosure, a moderate explosion occurred and the inside of the hood was immediately in flames. The cleaner threw down the vacuum hose and ran out of the room into the main shop area. The Shop Foreman, who was in the main shop area, heard the explosion, looked in the room, and saw the fire. He instructed a building employee to pull a fire alarm box and proceeded to a telephone to call the Fire Department. The fire alarm was received over the alarm system at 4:37 P.M. The Fire Department responded with a 1000 gpm pumper, emergency truck, and ambulance. Auxiliary firemen responded from elsewhere in the plant. In approaching the building, the firemen saw the bank of filters outside the building on the north side completely enveloped in flames and proceeded to that location. Appendix E, Figures E-4 and E-5, shows views of the filter bank. The booster line from the pumper was used on the fire until a 50-foot section of 2 1/2-inch hose, "Y"ed to two 150-foot sections of 1 1/2-inch hose, could be put into operation from a fire hydrant. The filter fire was brought under control in a matter of minutes. At about this time the sprinkler system motor gong on the outside of the building started to ring, which indicated that the building sprinkler system had actuated. Firemen then entered Building 9766 and found the fire burning inside the grinder hood. The sprinkler head located above the hood controlled the fire, as can be seen

in Appendix F, Figure F-1. The sprinkler system was turned off momentarily and this fire was extinguished with two CO<sub>2</sub> fire extinguishers. A short time later the odor of burning wood was detected and the sprinkler system was turned back on. The burning wood odor was traced to the attic where a small fire was seen around the juncture of the low roof with the high bay. The fire could not be reached readily from inside the attic so firemen went outside and gained access to the first level of the roof by ladder and removed a window from the high bay to get at the fire. The sprinkler system was turned off again and complete extinguishment was accomplished with water from the 1 1/2-inch hose lines. The attic fire was started from the overheated duct above a drop ceiling on the underside of the first-level wooden roof deck. The fire traveled horizontally between roof joists, see Appendix F, Figure F-3, and vertically to the high bay roof, and actuated a sprinkler head. Appendix F, Figure F-4, shows the vertical travel of the fire and the location of the sprinkler head. The fire was out and the all clear given at 6:08 P.M.

Figure F-1. OVERALL VIEW OF HOODED GRINDER.

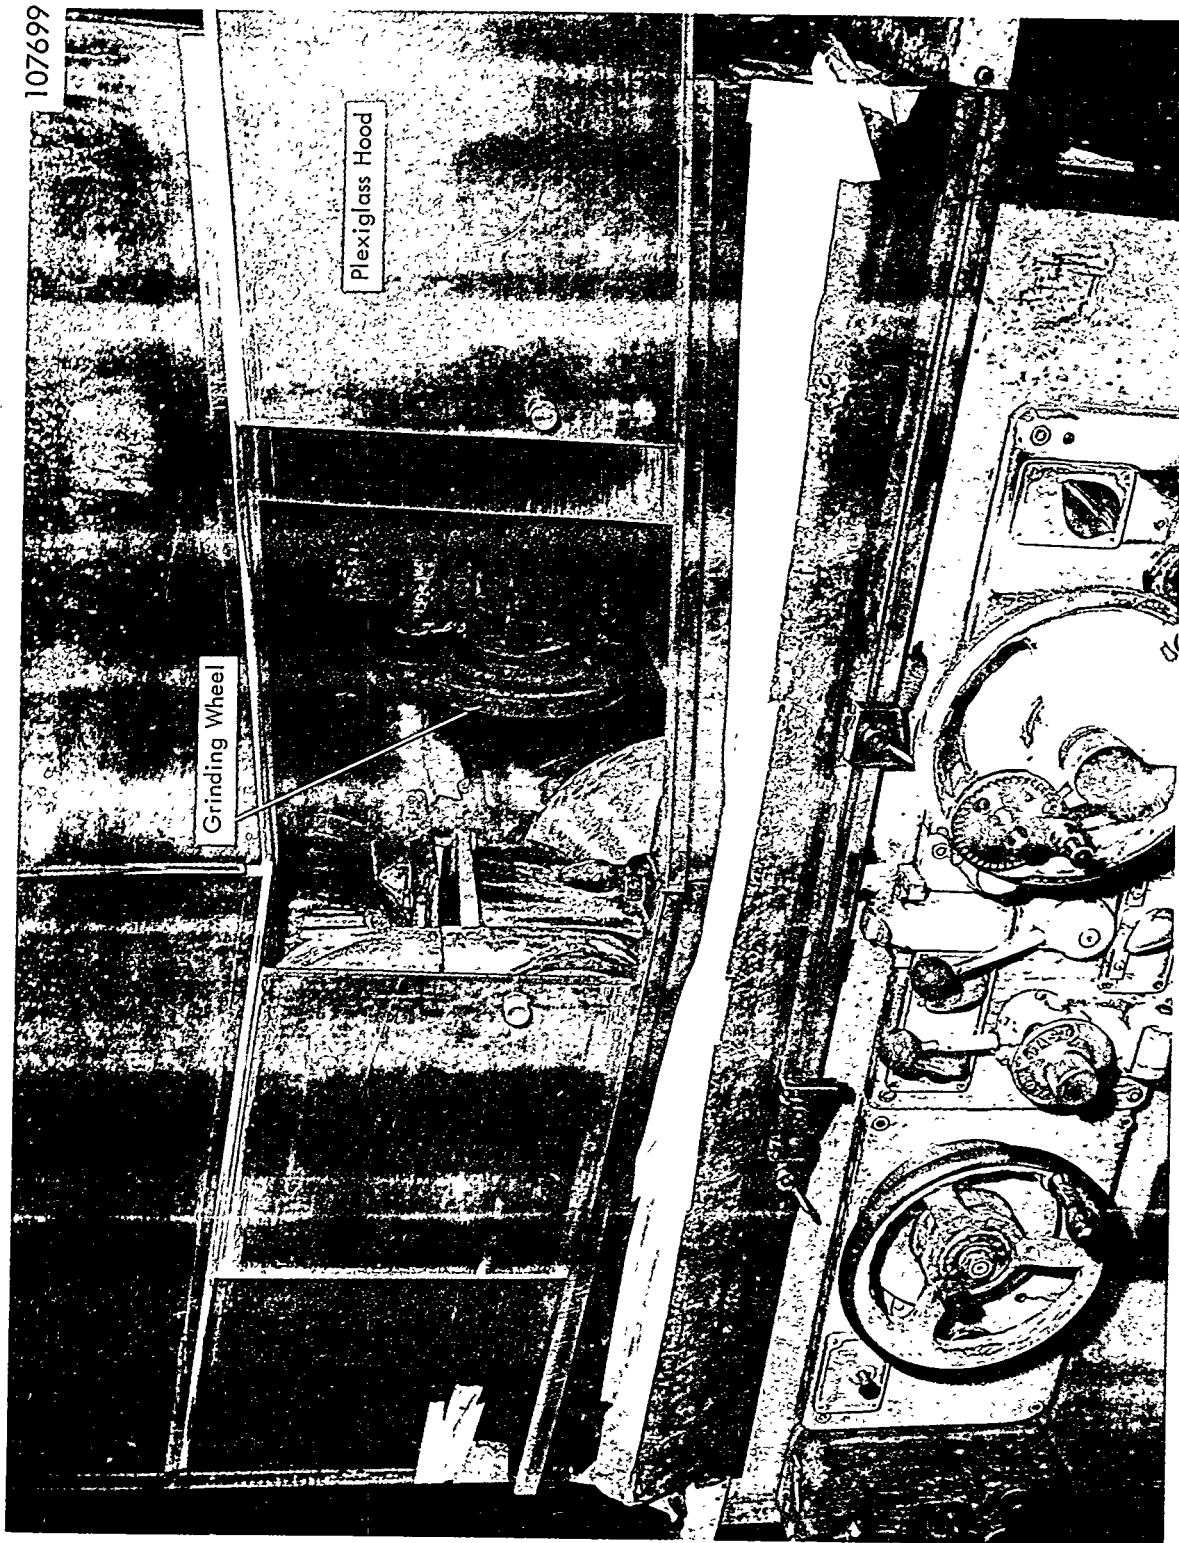
Figure F-2. CLOSEUP VIEW OF HOODED GRINDER.

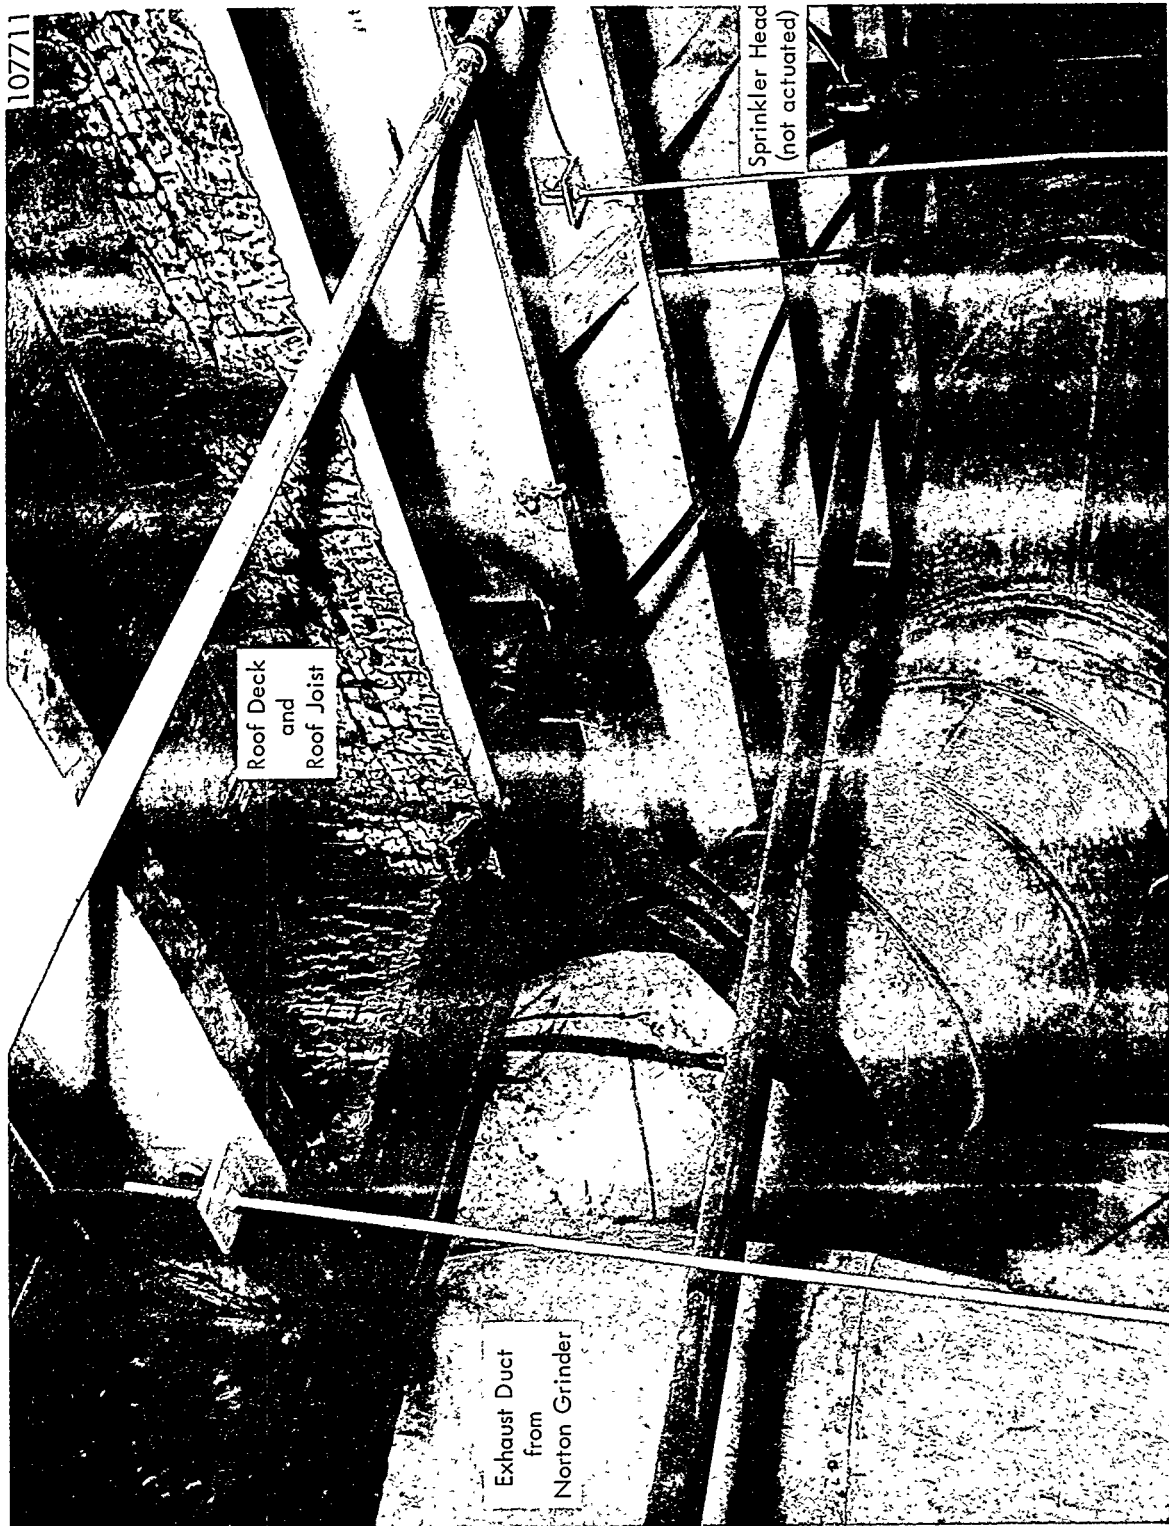
Figure F-3. CHARRED ROOF JOISTS.

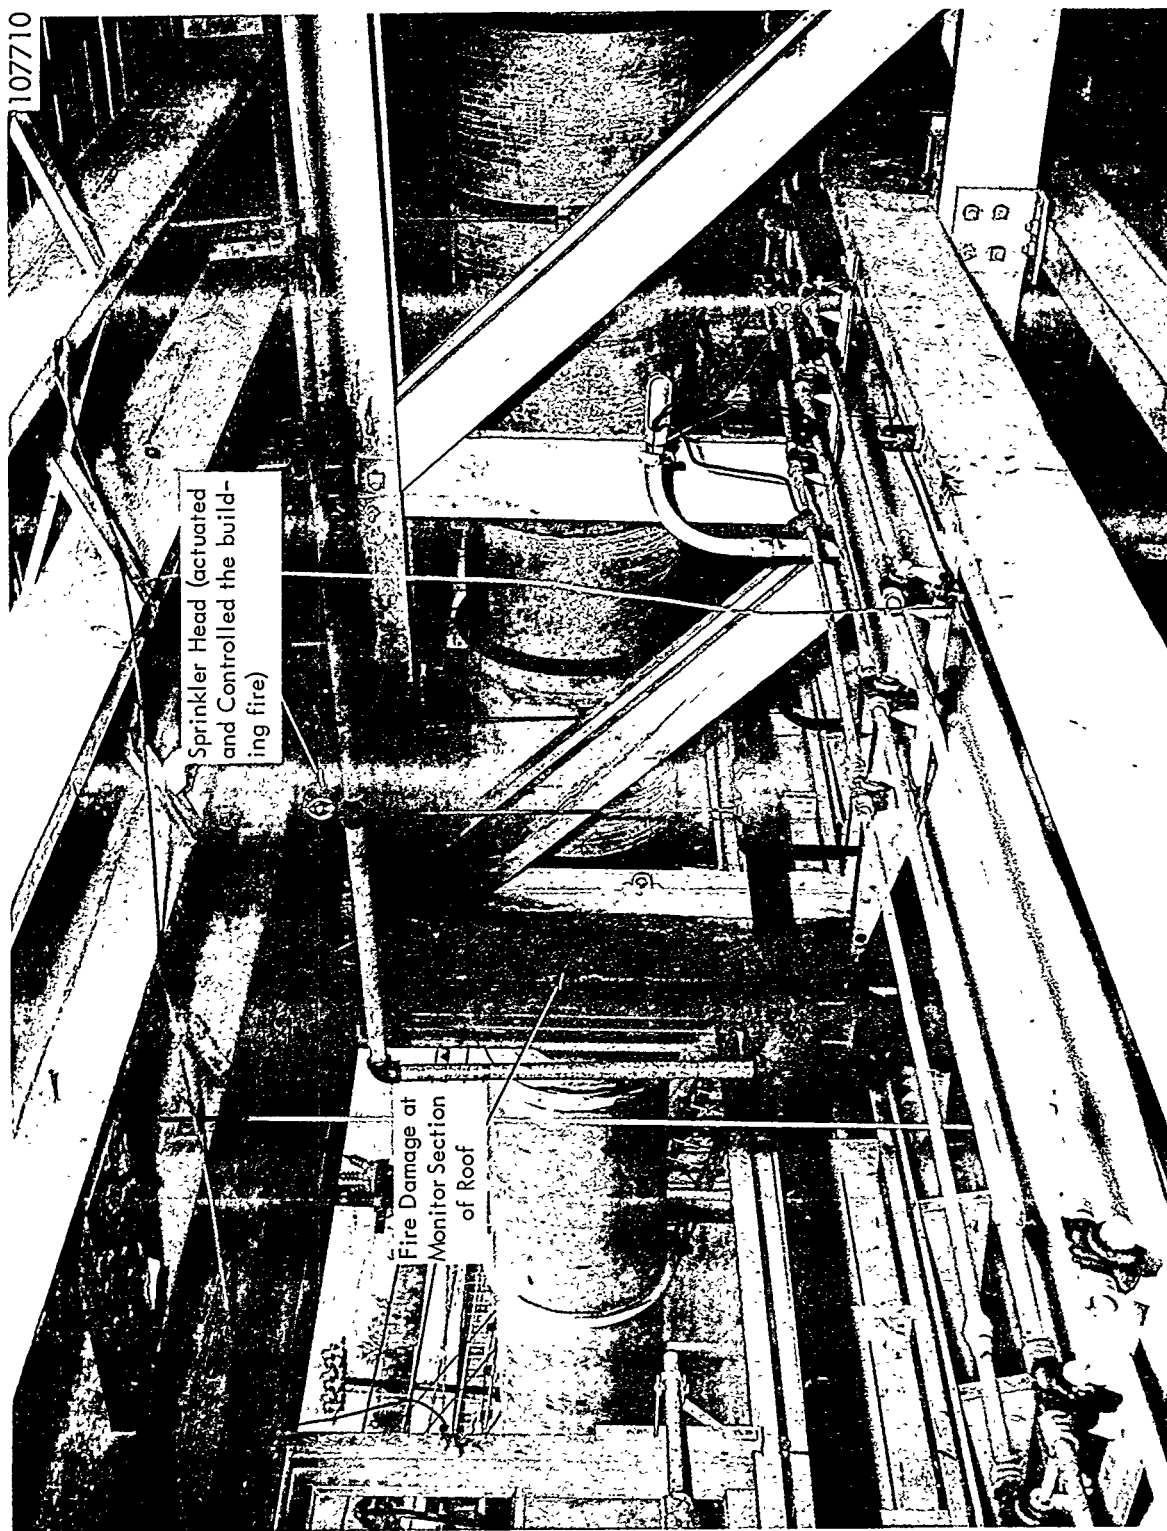
Figure F-4. VIEW SHOWING VERTICAL TRAVEL OF THE FIRE AND THE LOCATION OF THE SPRINKLER HEAD.

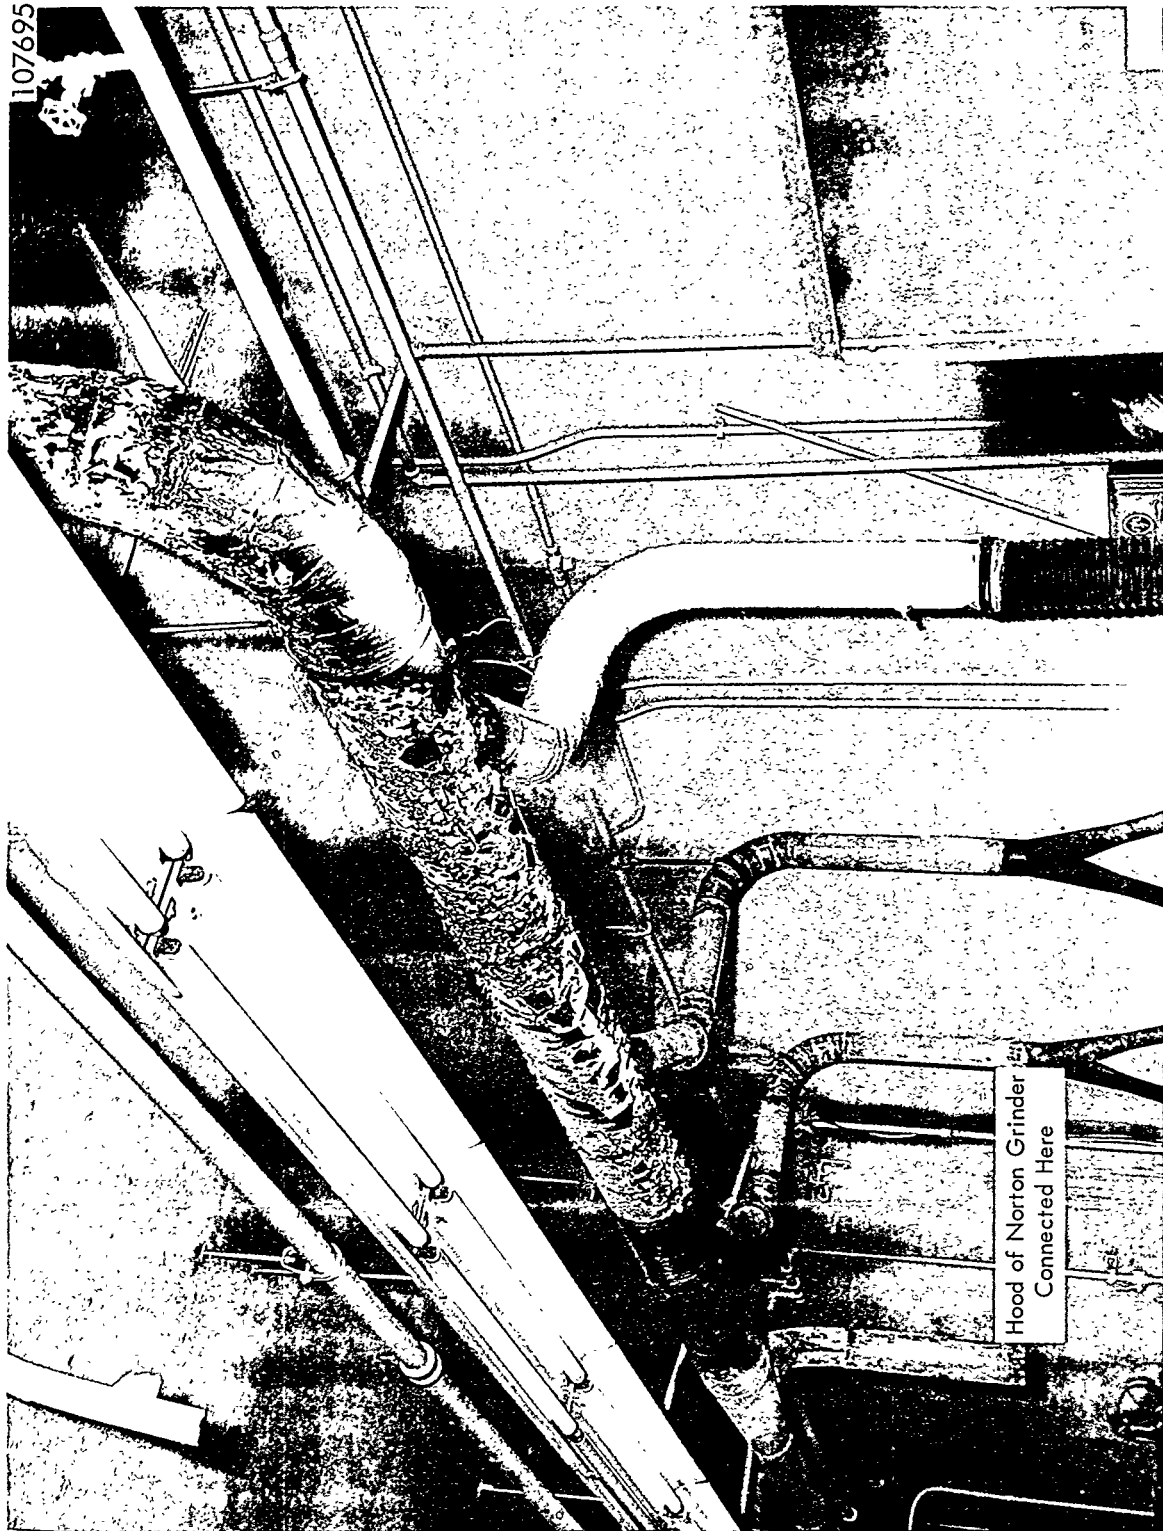
Figure F-5. EXHAUST DUCT SYSTEM FROM HOOD TO CEILING.

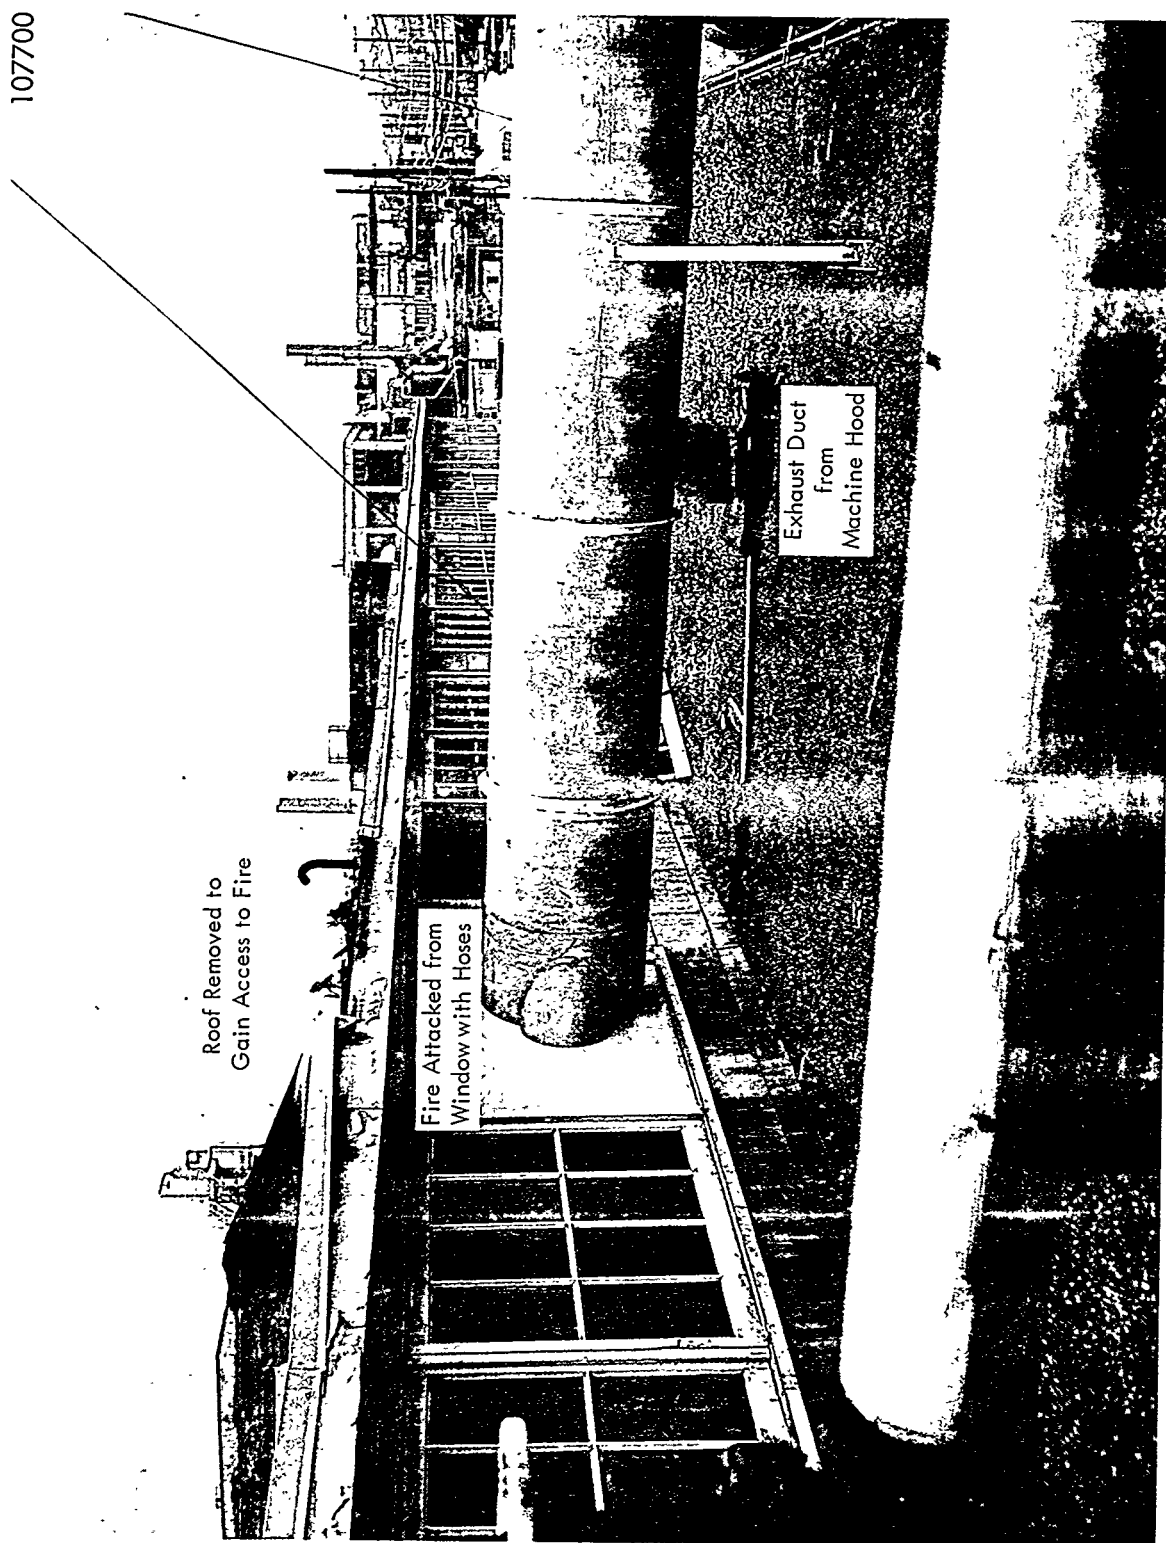
Figure F-6. EXTERIOR EXHAUST DUCT FROM MACHINE HOOD.
